Classic 1963 Vespa GS150 Restoration Project

The restoration covered here is of a VBS Vespa, with GS specification modifications.

Scooter restoration specialists AllVespa performed the restoration. The scooter started out as a 1963 VBC with a 150-cc engine. Although this restoration was performed by a professional company, it gives the private owner/restorer an insight into what is required to make the older Vespa's serviceable again.

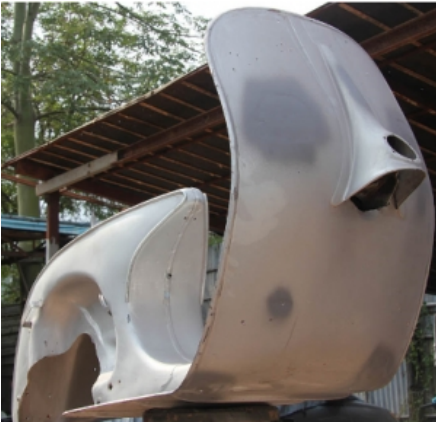
The Vespa was purchased and restored by AllVespa in Vietnam where the scooter has been a popular form of transport for many years. Although the Vespa's have proven to be reliable machines, the company disassembles every machine to check for damage or cracks on the chassis which may need welding. (Anyone restoring one of these classic scooters is well advised to follow this example)

Disassembly of a scooter ideally should be done on a lift to put the scooter at decent working height. This is particularly important with scooters as many of their mechanical components are located below the body/chassis panels (similar to a car).

Although the pressed steel chassis has proven to be very robust, it is essential to have the paint removed by sand or grit blasting. This process will give the mechanic chance to fully inspect the chassis.
