Vespa ss90 Restoration Project (Part 2)

Monday, May 20, 2013

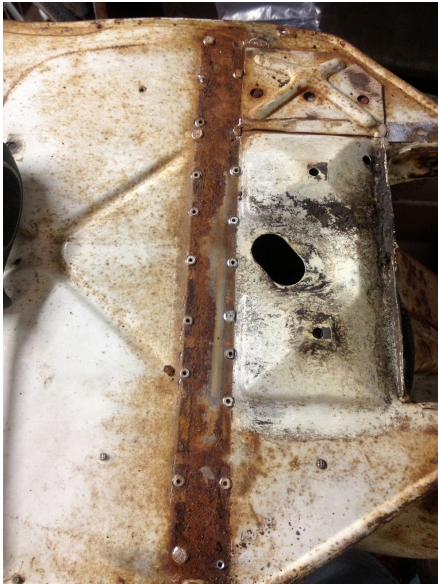
The support has been removed. Vespa didn't paint or prime before the support was attached so it was very rusty.
