Vespa ss90 Restoration Project (Part 2)

Monday, May 20, 2013

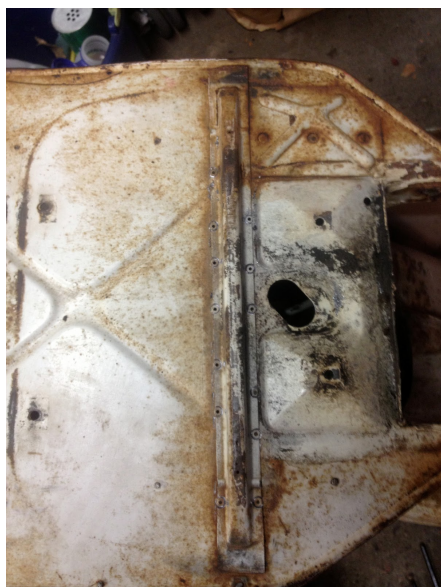
It is hard to see. But there are a lot of spot welds drilled out.

I am cutting out the spot welds on the floorboard supports. Eventually I will get to the horn cover and the rest of the legshield itself. I can practice without screwing much up. I started by center punching the spot weld and then using a spot weld drill cut it out. I immediately broke the teeth off of the first one. The second went a bit better but still broke it. Finally I went to the step bit. I punched a hole all the way through but it seems to be the easiest way for me. It wont leave the spot weld to grind off afterwards.

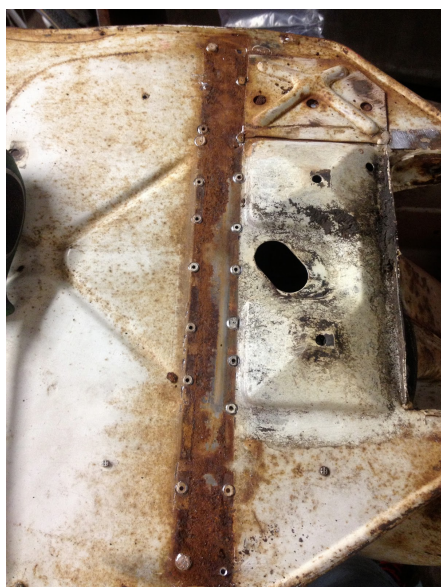
The support has been removed. Vespa didn't paint or prime before the support was attached so it was very rusty.
