## Classic 1963 Vespa GS150 Restoration Project

The restoration covered here is of a VBS Vespa, with GS specification modifications.

Scooter restoration specialists AllVespa performed the restoration. The scooter started out as a 1963 VBC with a 150-cc engine. Although this restoration was performed by a professional company, it gives the private owner/restorer an insight into what is required to make the older Vespa's serviceable again.

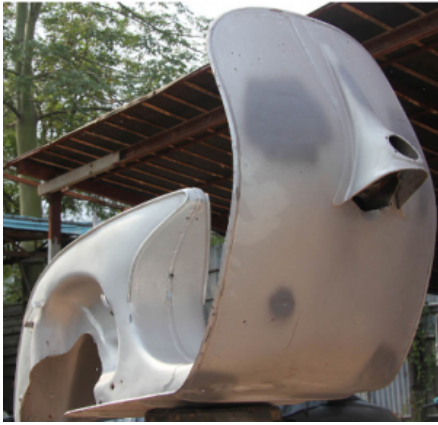
Disassembly of a scooter ideally should be done on a lift to put the scooter at decent working height. This is particularly important with scooters as many of their mechanical components are located below the body/chassis panels (similar to a car).

Although the pressed steel chassis has proven to be very robust, it is essential to have the paint removed by sand or grit blasting. This process will give the mechanic chance to fully inspect the chassis.

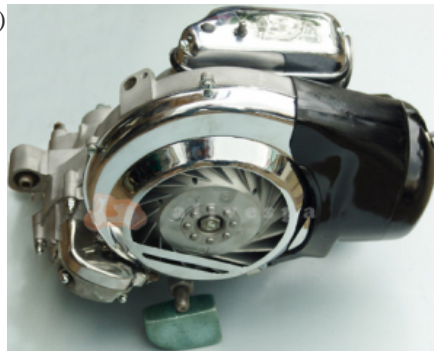
As with most restorations, it is prudent to replace certain components. In this restoration the following components were replaced for safety and reliability reasons (and appearance in some cases)

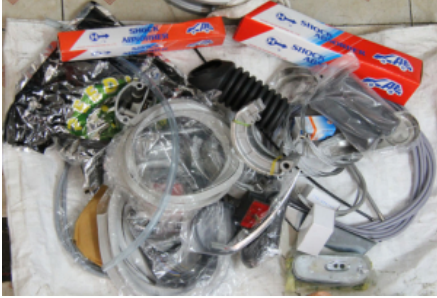
In addition, the 150-cc engine was fully rebuilt. Although the Vespa 2-stroke is a relatively reliable design, wear on certain components is inevitable. In particular the 2-stroke lubrication system gives only a minimal amount of lubrications to pistons and crank bearings, but at the same time the burnt oil (after combustion) will slowly build up in the muffler and around the exhaust port, which will greatly reduce performance.
