## Star Vespa - Restoration Process

We start with **original** Piaggio - Italian unmodified matching number Vespas.

The Vespa are stripped right down to their component parts prior to a full 1st Class restoration. Below is a brief run through of the restoration process.

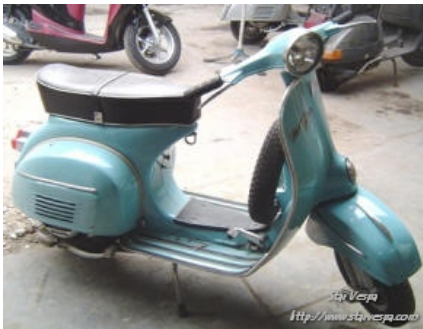
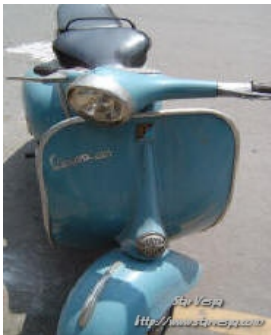
We always start with un-restored Vespa which is still in good condition.

Due to the climate in south Vietnam rust is not such an issue as it is on bikes that have spent the last 40+ years in Europe. To start the Vespa are taken apart carefully and all items removed from the body. The body is then stripped to bare metal and replacement metal welded in if necessary.
