Star Vespa - Restoration Process

The Vespa are stripped right down to their component parts prior to a full 1st Class restoration. Below is a brief run through of the restoration process.

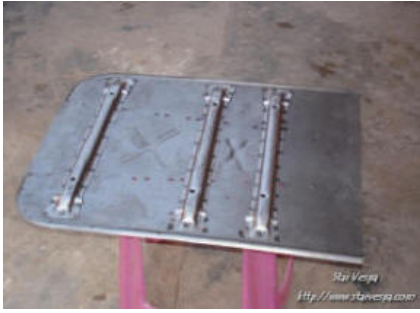
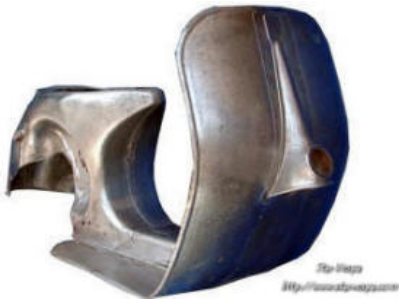
As a matter of course we replace the floor plans on all our vespas with a thicker grade of steel, these floor pans are imported from India and come off the original Piaggio presses. Once all traces of rust have been removed, Any dents or imperfections are beaten out this often as long as 2 days! Unlike other restoration companies we avoid using excessive body filler! The next stage is to put the scooter on a jig to check for 100% trueness.

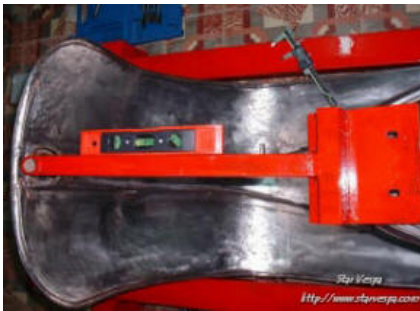
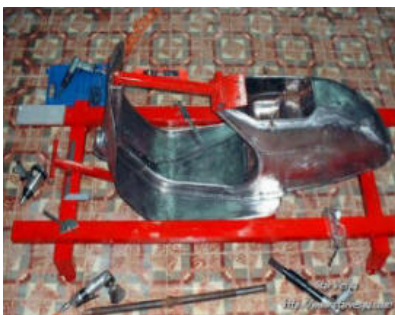
Next the steel of the bodywork is polished to a High finish, to remove any tarnish or oxidization. Immediately all panels are acid etch primed . Acid etch primer firstly etches into the metalwork sealing the bare metal and acting as a bonding agent between metal

and zinc primer. The zinc primer is an anti rust treatment- very tough and durable. This is followed by 2k ICI high build primer, and finished with 2k ICI acrylic color. Depending on paint used (either solid or metallic) we finish off with 2k ICI Clearcoat. Quite a process- both in terms of cost and labor. The end result is a perfect finish that lasts for many years. Infact ICI research quotes a 30 year life expectancy. Quite different from the average of 2 years for a typical restoration in Vietnam.

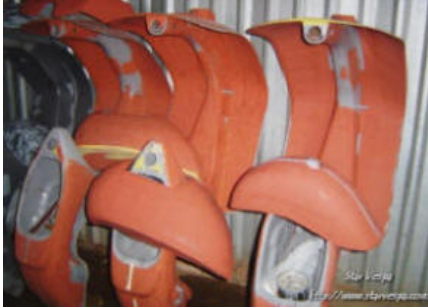
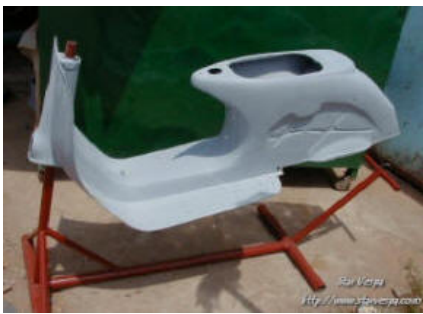
We are the only scooter restoration shop in Vietnam using this system, we are also the only company using a heated spray booth. Which is itself the only ICI spraybooth in all of Vietnam! The booth belongs to ICI international for whom I personally have trained Vietnamese body shops in modern painting techniques. We spend on average 19 times the amount on body restoration materials than other local Vietnamese scooter restorers. Are bikes are painted to last!

Once this is done and all metal work is sealed the bikes go through the usual process of painting. However unlike any other company restoring Vespa in Vietnam all our paint products are tough, durable long lasting 2 pack acrylic. The final painting process is done with high quality Baked Enamel paint. This is a multi layer painting process then it is cured in a clean booth at 140 ° C for 3 hours. This hardens the paint and allows a more rapid curing process.
