61 Vespa VBB Restoration Project (Part 6 of 6)

Follow along with me as I do my first Vespa restoration -- on a 1961 VBB 150cc vintage Vespa
Originally Posted on <http://vbbrestore.blogspot.com.au>

Free at Last, Free at Last, my Shifter Tube is Free at Last

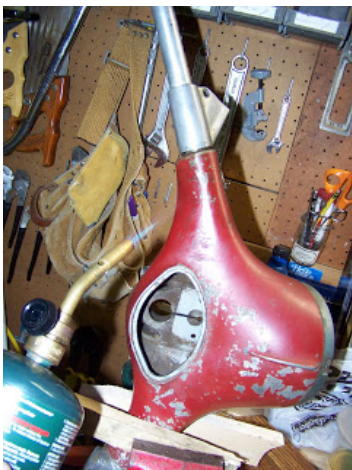
Here's what finally worked. I removed the handgrip, then clamped the headset in my vice (protecting it with wood blocks over the metal vice faces), with the shifter tube pointing up. Then I doused it in PB Blaster (which I had been doing for the last month or so), and started heating up the headset with a blowtorch in the section where the shifter tube was. Including inside the headset. And I mean really heated it up -- smoke was coming out the top of the tube! I squirted more PB Blaster in there (fun when it catches on fire). Then I put a 2x6 into the headlight opening of the headset (for leverage), and used a pipe wrench on the shifter tube. (Yeah, I

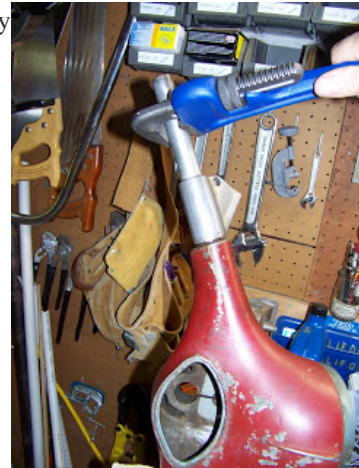
was worried about scratching it up, but then figured it's worthless if I can't get the tube out, no matter how pretty it looks!) So using the 2x6 to keep it from turning in the vice, I cranked on the pipe wrench. And finally, slowly, it moved! Yay

So I worked it back and forth like that with the pipe wrench till it was moving a little more freely, then forced a screwdriver gently under the flange that holds the clutch lever to pry it up, and was able to get it to start extracting. Once I got it out about 1/2 inch, then I was able to grab the tube by hand (using a rag to keep from burning my hand -- it was still hot) and pull it all the way out.

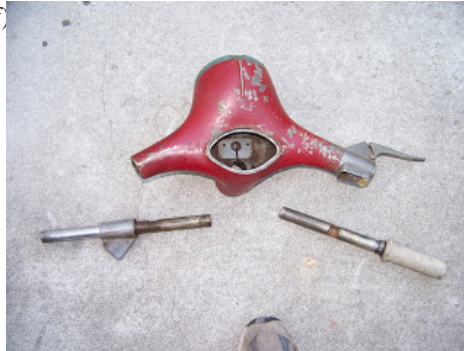
It was pretty rusted at the outermost part of the tube that was still inside the headset, which I guess makes sense. But mostly surface rust -- I was able to sand it off with emery paper and now it moves smoothly in the headset. The inside of the headset is fine, no corrosion there (gotta love aluminum or whatever it's made of)
