## 61 Vespa VBB Restoration Project (Part 6 of 6)

Follow along with me as I do my first Vespa restoration -- on a 1961 VBB 150cc vintage Vespa  
Originally Posted on <http://vbbrestore.blogspot.com.au>

Free at Last, Free at Last, my Shifter Tube is Free at Last

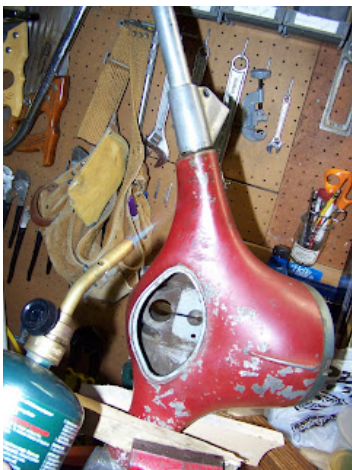
Here's what finally worked. I removed the handgrip, then clamped the headset in my vice (protecting it with wood blocks over the metal vice faces), with the shifter tube pointing up. Then I doused it in PB Blaster (which I had been doing for the last month or so), and started heating up the headset with a blowtorch in the section where the shifter tube was. Including inside the headset. And I mean really heated it up -- smoke was coming out the top of the tube! I squirted more PB Blaster in there (fun when it catches on fire). Then I put a 2x6 into the headlight opening of the headset (for leverage), and used a pipe wrench on the shifter tube. (Yeah, I

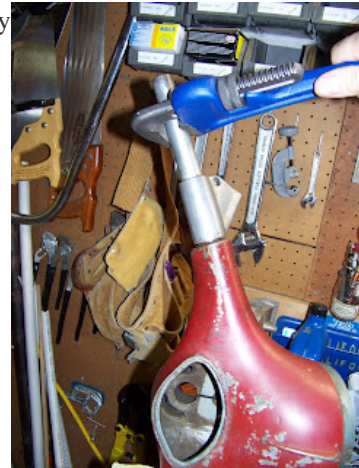
was worried about scratching it up, but then figured it's worthless if I can't get the tube out, no matter how pretty it looks!) So using the 2x6 to keep it from turning in the vice, I cranked on the pipe wrench. And finally, slowly, it moved! Yay

So I worked it back and forth like that with the pipe wrench till it was moving a little more freely, then forced a screwdriver gently under the flange that holds the clutch lever to pry it up, and was able to get it to start extracting. Once I got it out about 1/2 inch, then I was able to grab the tube by hand (using a rag to keep from burning my hand -- it was still hot) and pull it all the way out.

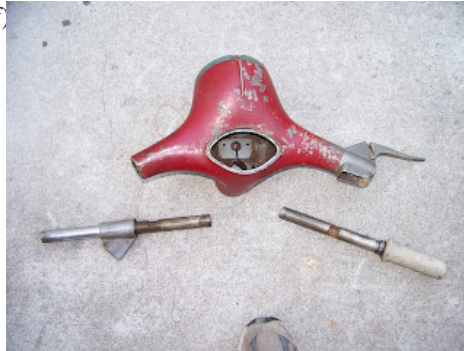
It was pretty rusted at the outermost part of the tube that was still inside the headset, which I guess makes sense. But mostly surface rust -- I was able to sand it off with emery paper and now it moves smoothly in the headset. The inside of the headset is fine, no corrosion there (gotta love aluminum or whatever it's made of)
