HOW TO FIX A VESPA GEAR SELECTOR PROBLEM

Originally Published at Star Vespa

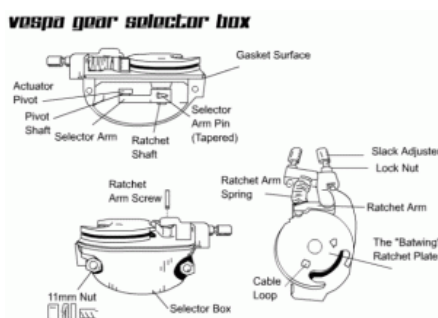
The Vespa gearbox has not changed in a very, very long time so this information should be helpful to most every Vespa owner. The Selector box rarely needs attention; however, it is an integral part of the transmission and can break down just like any other moving part. The box selects the current gear by pulling a rod back (you can see this rod in the cruciform replacement area) and forth through the transmission. if this box fails, you will be unable to select gears until the problem is fixed. Below we will outline some procedures for inspecting and setting the gear selector box.

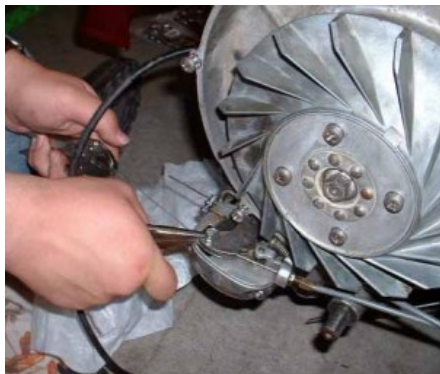
One of the more tricky cable installations on a Vespa would have to be the gear selector cables. if the cables do not appear to be broken, but the shifting is weird or not working, carefully inspect the gearbox for damage (namely the selector arm as they may snap, there are more details on this below). You will need a 7 and an 8 mm spanner, two pairs of Vise grips (one needlenose preferably), a set of cables and a friend to help. There is a single screw at the bottom of the flywheel that hold the selector box cover onto the engine. Undo this screw and pull the cover aside to reveal the Selector Box Parts. Tighten the slack adjusters so they protrude into the selector box.

Once you are into the gearbox begin by undoing the cable nipples using two small spanners. Pull the nipples clear of the box and set them aside. To replace the cables on a P series you will have to open the headset. To open the headset, undo the 4 screws on the

bottom of the headset and lift it as much as you can without yanking on it. push the speedometer cable (large cable right near the front wheel) toward the rear of the bike and the headset cover will pop straight up. you should now be able to see the inside of the headset. Apply a piece of duct tape to the speedometer cable, just below the locking ring (the thing attached to the speedometer under the headset). Unscrew the locking ring and allow it to rest on the duct tape (that way it won't fall into the fork tube). The headset will still be retained by wires. you can usually flip the headset back and work unimpeded, but if you know where everything goes, you may choose to unhook all of the little wires. There is a disc on the inside of the headset attached to the end of the gear selector handlebar. there should be two cables in this disc. These cables are the gear selector cables and they run down to the gear box. To renew these cables, carefully rise them from their seating in the disc and pull the cable straight out. Once one cable is out, replace it by feeding it down the same outer cable and then move onto the next, so they don't get out of order at the gearbox. Once both cables are seated in the disc, set the handlebar so the dots line up. Don't bother closing the headset yet.

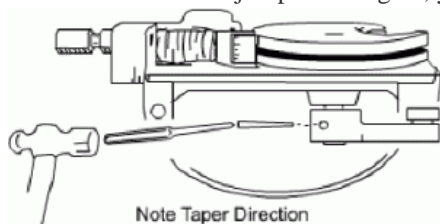
The selector arm is a small cast piece of metal that forms the physical connection to the gear selector rod inside the engine. Since this part is under a lot of stress it may be vulnerable to cracking off due to lack of gearbox oil, sudden stress from the selector rod (usually from jumping out of gear) and bad casting. A key sign that this may be a problem is if the handlebar moves far past 1st gear without engaging a gear. If you notice this behavior kill the engine and undo the 11mm bolts that hold the gearbox to the engine. gently pull the gearbox clear of the engine (there is a paper gasket between the selector box and the engine case). If indeed the selector arm has broken and you are in the middle of no where, try to find some brass or aluminum wire and make multiple wraps around the selector arm and ratchet shaft as an emergency repair. Shift as little as possible and try to get safely home. The selector arm usually snaps at the ring around the ratchet shaft and it can only be repaired only by ordering a whole new part. If you have a worn cruciform that jumps out of gear, you are at risk for this piece snapping off.

When ordering new parts, request a selector arm and a new tapered pin, as the pin is likely to be difficult to refit. you will need a ballpeine hammer and a small punch suited to the size of the hole. You may also need a reamer (taper tool) suitable to the size of the hole. Start by removing the cabling and get the box into a well lit area. On a wooden surface, tap out the pin as per the top picture. It will fall out completely with only a small bit of force. Crank the selector arm far past the fourth gear position as in the diagram. with the pin removed, slowly pull up on the batwing and place the new ratchet arm on the shaft. Line up the holes and punch the new pin back into place as shown in the bottom diagram. The pin should go all the way in. If it stops, adjust the position of the selector arm on the ratchet shaft and try again. If you cannot get it in, use a small reamer to redefine the taper on the new part. Once you have reamed the hole a small amount, refit the pin and try to bang it in. keep adjusting the taper until it will allow the pin to fit snugly in the hole. Once you are done, refit the selector box and cabling (see above for instructions). Drain and fill your gearbox and replace
